# Variable Voltage Substation Electrical Fire

## *Environmental Radiological Assistance Directory*

John Seabury, PE, CIH

SLAC Accelerator Directorate Quality and Safety Manager

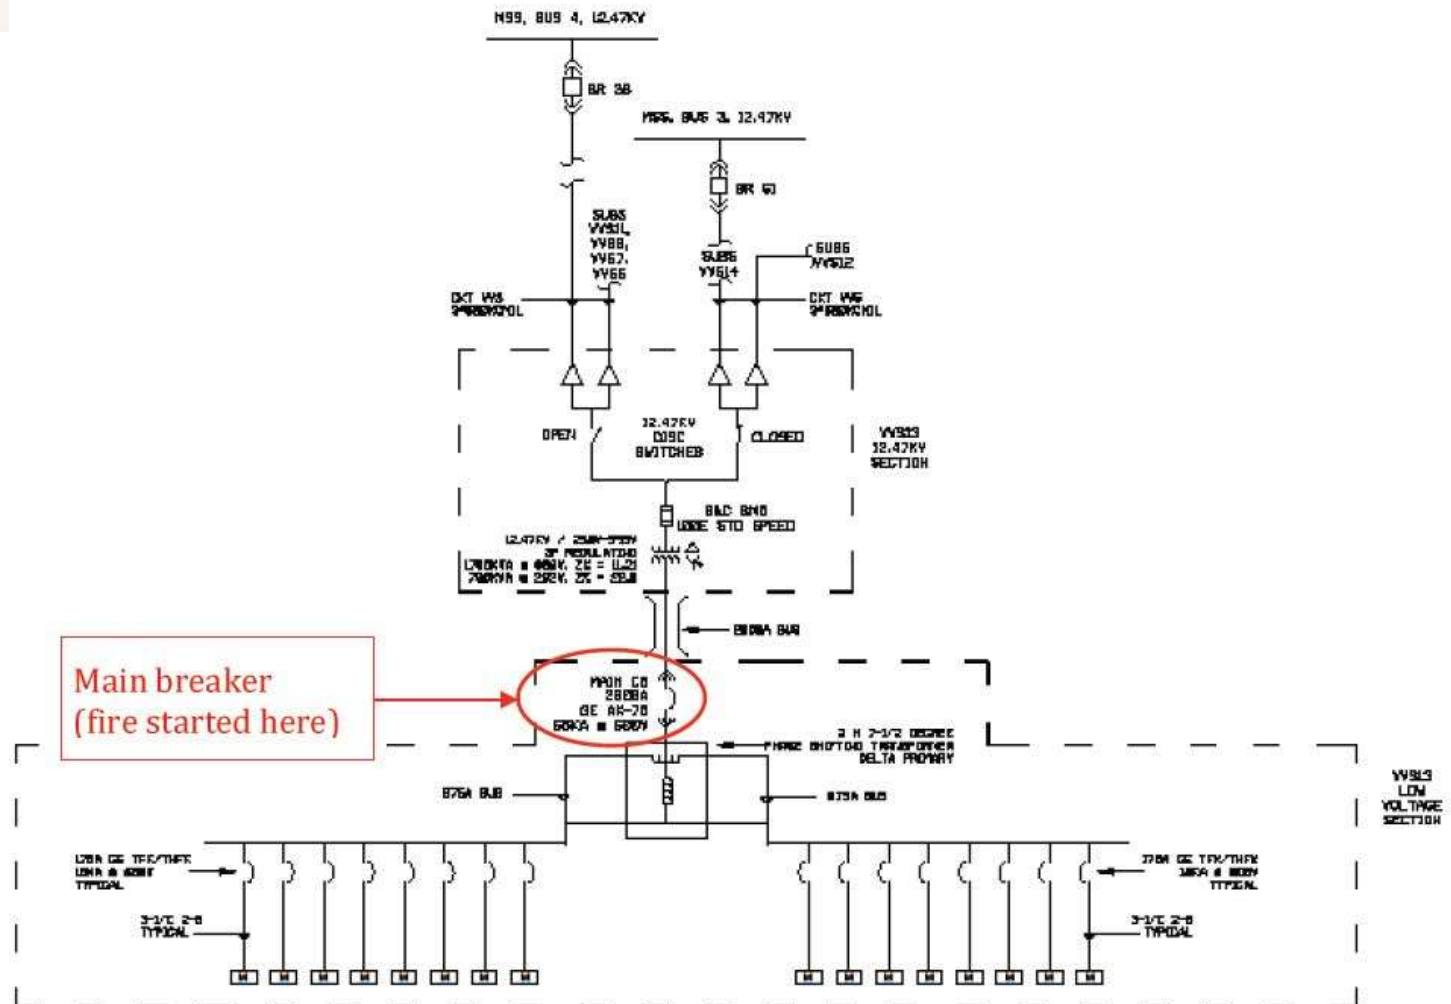
# One-line Diagram VVS-13

- Fire started as a result of an arc flash and ongoing electrical faulting between the input connectors of the secondary main breaker
- Unclear what started the arc flash. May have been high resistance, may have been contact with a displaced object within the cabinet. Downstream breaker may have contributed.
- Root Causes
  - Poor maintenance condition of VVS 13
  - Lack of effective stewardship of the VVS system by Facilities Department
- Contributing Causes
  - Fault protection systems inadequate
  - Lack of routine maintenance
  - Lack of condition assessment
  - Changes in operations increased frequency of breaker switching
